## Purpose

## Freeze Damage

### Girard, Furrion Tankless Water Heaters

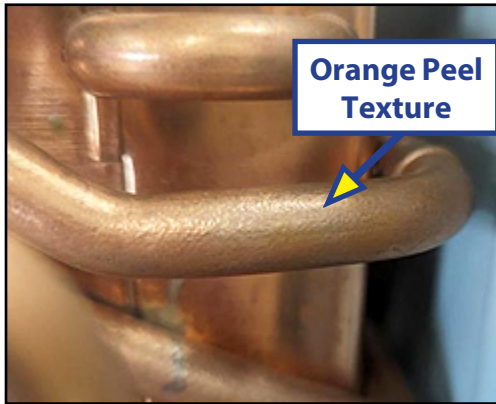
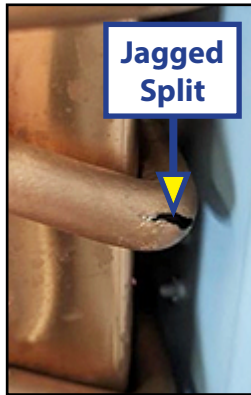
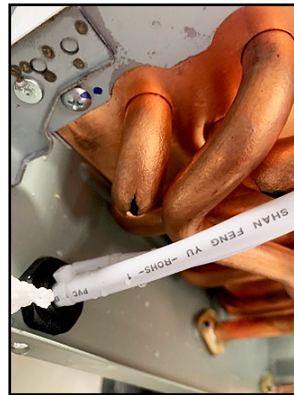
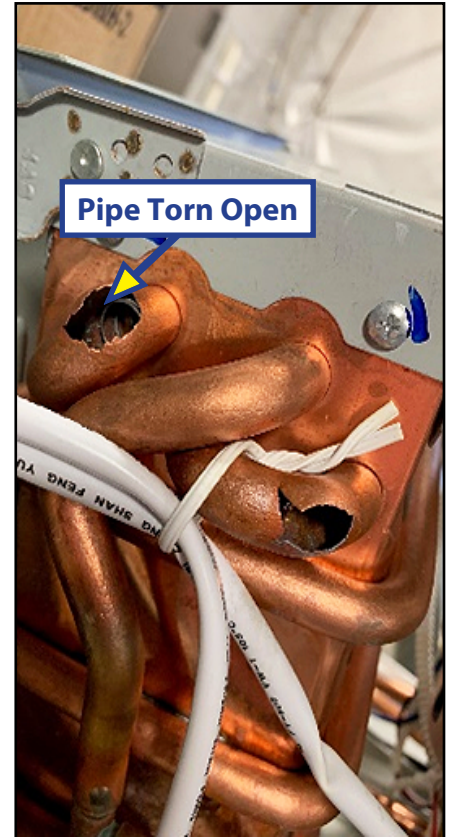
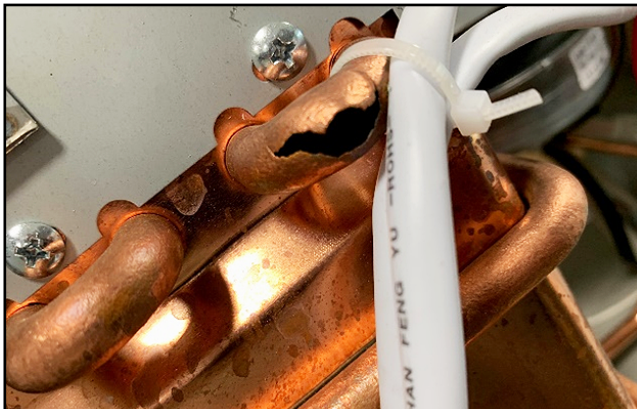
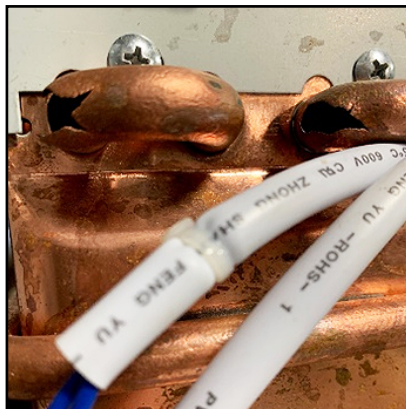
Potential freeze damage issues on both the Girard and the Furrion tankless water heaters are pictured. This may include:

1. An orange peel texture can be both seen and felt on the copper pipes. The only thing that will cause the orange peel texture is water freezing in the pipe.
2. Copper pipe bulging.
3. A jagged split in the copper pipe or instances where the pipe is torn open like a flower.

This document is designed to illustrate what freeze damage looks like on the Girard and Furrion tankless water heaters when the tankless water heater is not winterized properly or at all. If the leak is not clearly seen with the water heater installed it will need to be removed and the cover removed to provide a clear view of the leak. A clear photo of the leak is required for warranty consideration.

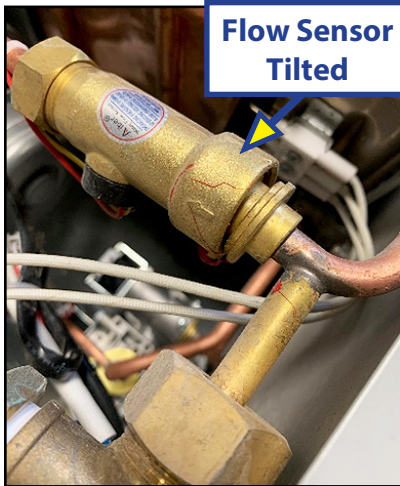
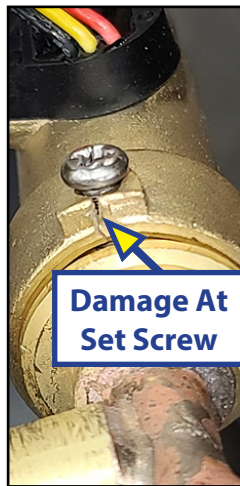
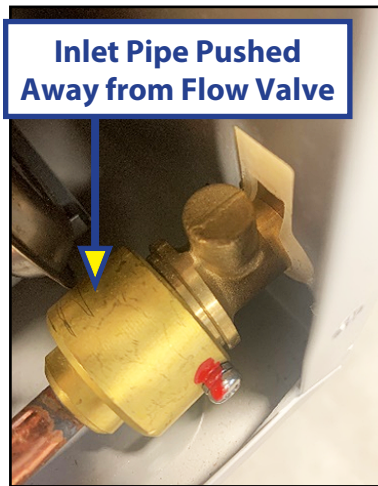
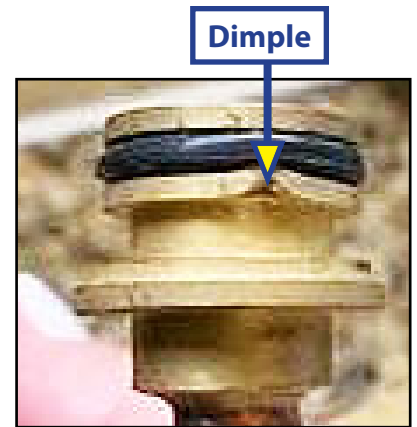
Girard, Furrion 42,000 BTU Water Heaters

Potential freeze damage issues on the Girard and Furrion 42,000 BTU models (without small tank on back) are pictured in the photos below.

1. Flow sensor pushed up from the inlet pipe and tilted.
2. Bottom of flow sensor cracked or broken around the set screw.
3. Inlet pipe pushed away from flow valve at back of the unit.
4. Dimple on the surface opposite the set screw.

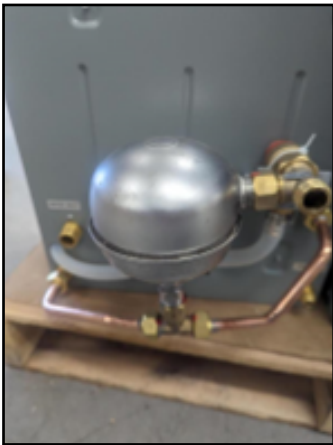
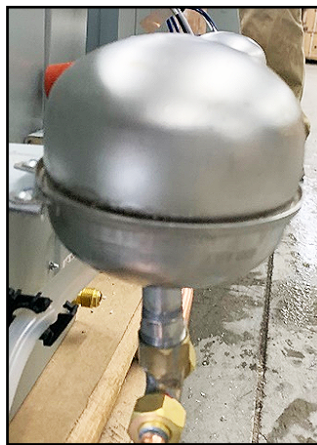
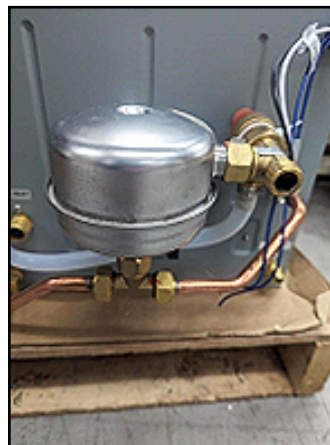
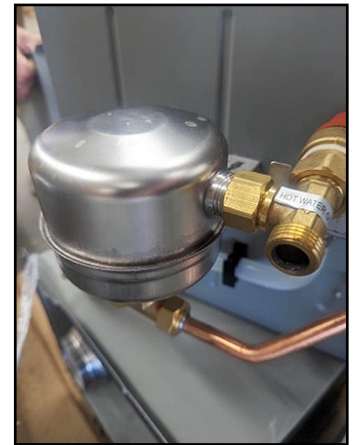
Furrion 60,000 BTU Model

Potential freeze damage on the Furrion 60,000 BTU model (with small tank on back) is pictured.

1. Tank expanded out to a ball.
2. Broken connection around the inlet or outlet pipe and the tank.
3. Pipe inside tank pushed out of the bottom of the tank.
