# REPAIR OF THE INVERTED GEAR RACK IN-WALL (SCHWINTEK) SLIDE-OUT SYSTEM

TSB Number:	146-001-2022		
Product:	Inverted Gear Rack In-Wall Slide-Out System manufactured between October 2021 and January 2022		
Date:	June 24, 2022	Labor Rate:	5.0 Hours Allowed (2.5 hours per side)

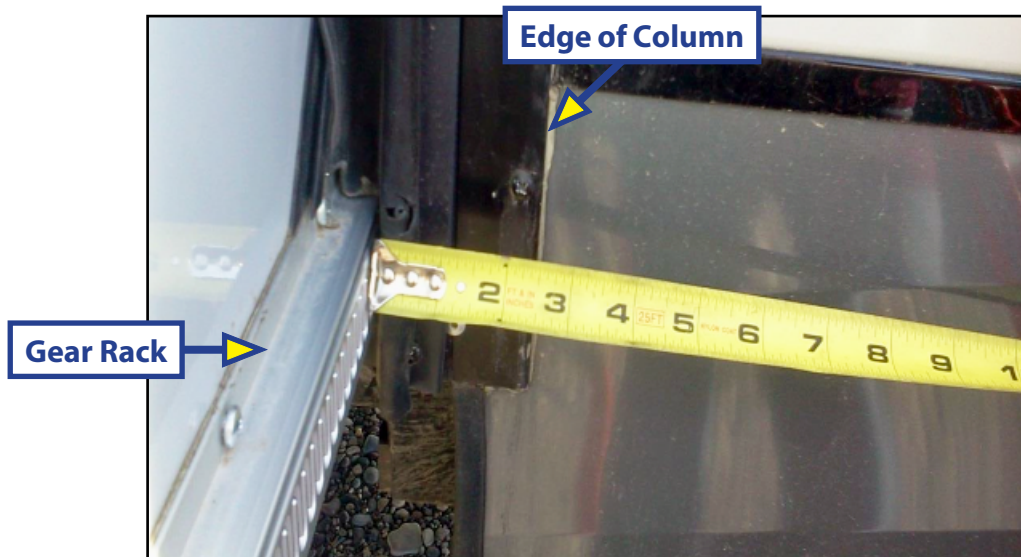
## Photos of Measurements After Completing Repair

1. Take measurements (similar to the measurement featured below) from the gear rack to the edge of the column with the tape measure pressed against the gear rack, not above or below it.
2. This measurement is best taken with the slide extended at 6 inches from the exterior of the coach and then again with the slide at full extension at all four corners for a total of eight measurements.

3. Tolerance is 2 3/8" to 2 5/8". Ideal measurement is 2 1/2".

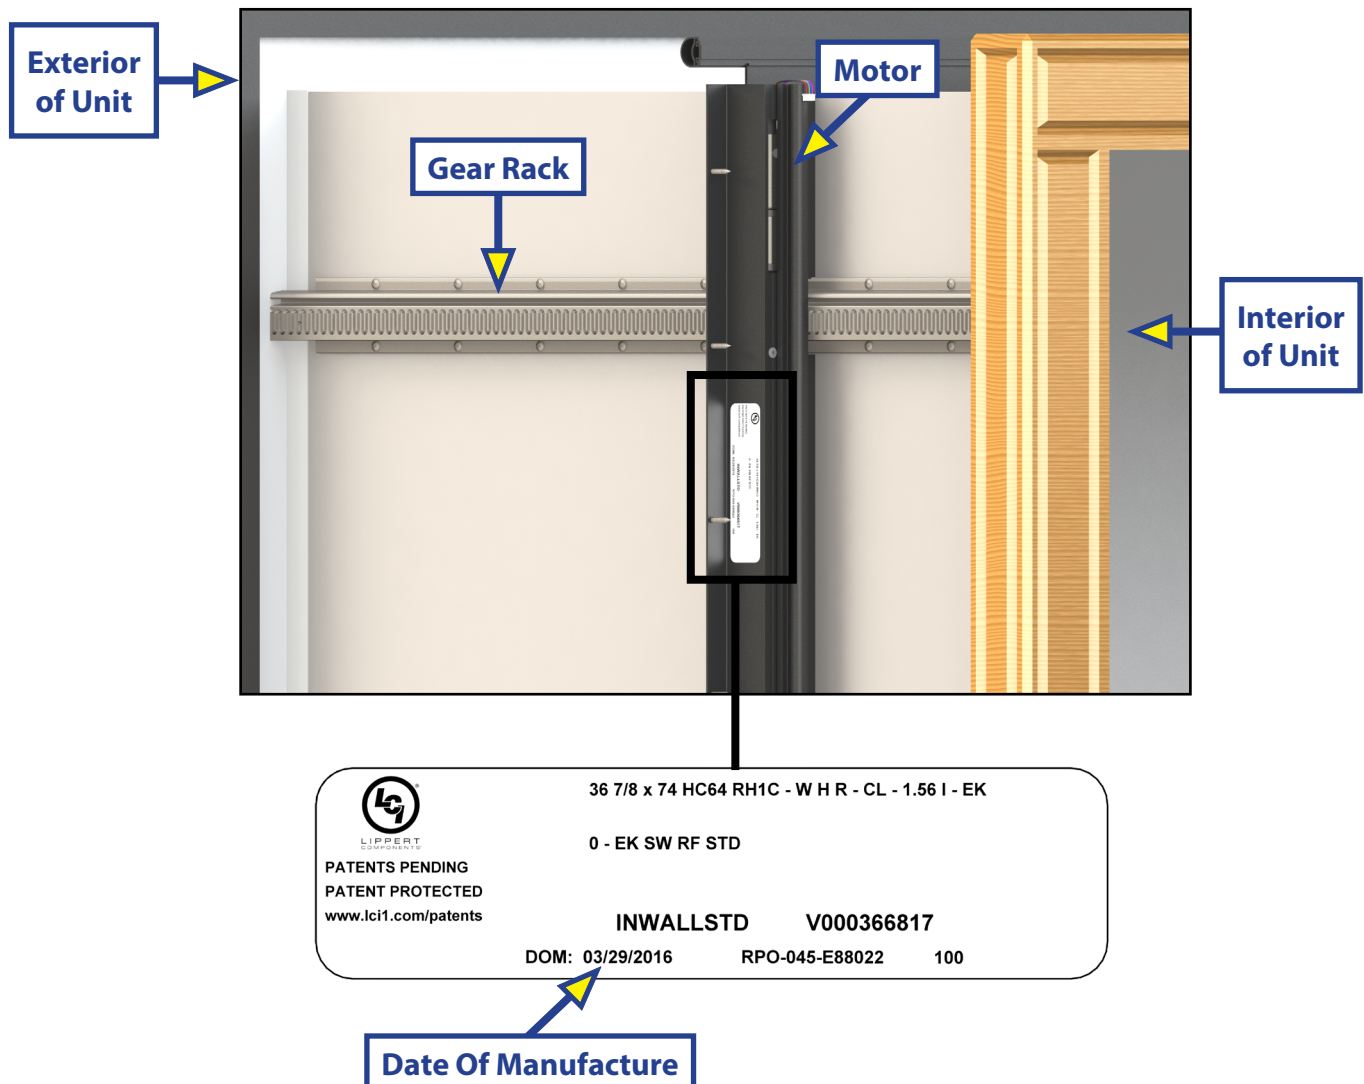
The specific inverted gear rack systems will have manufactured dates around Oct. 1, 2021, through Jan. 6, 2022. Dates are shown on the variant code tag located on the H-column. See location below.

**NOTE:** The tag featured is only a sample picture and not the actual variant code tag for the inverted gear rack slide-out.

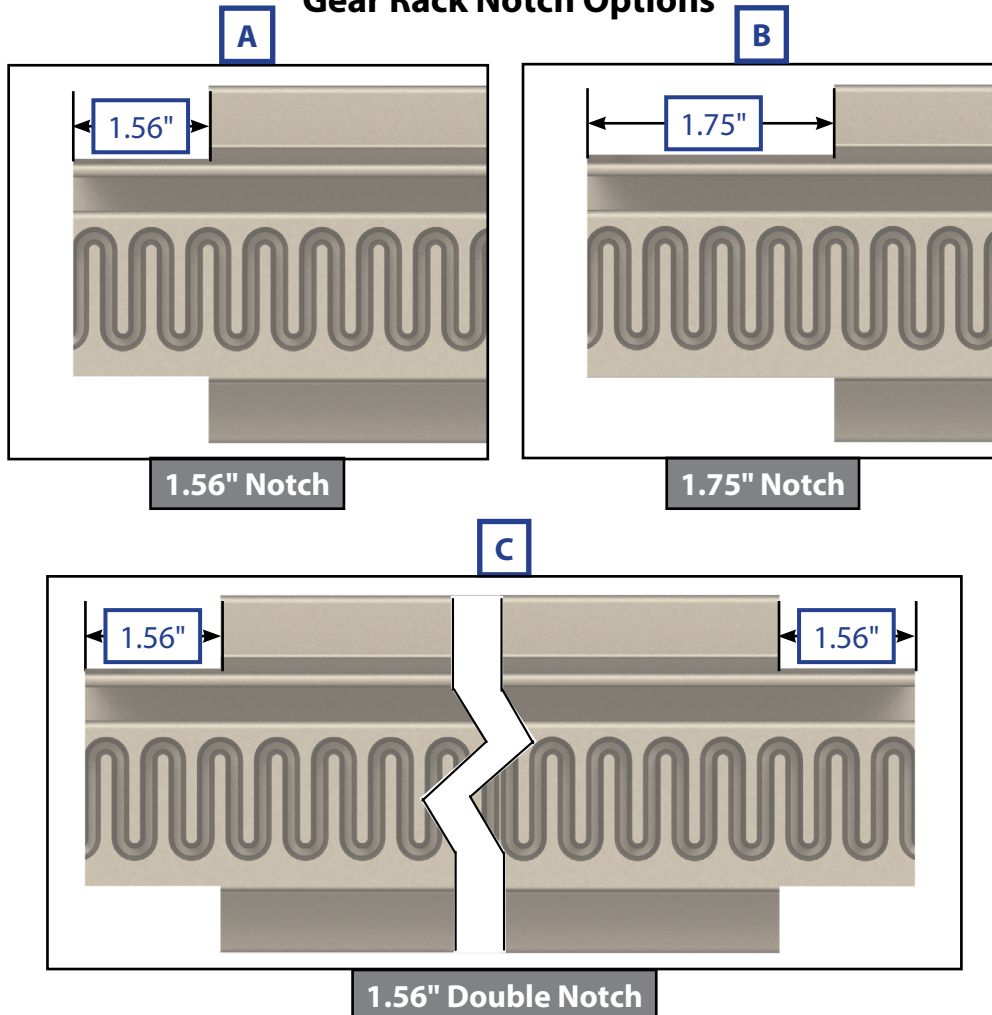
### Gear Rack Notch Options

The most common gear rack notch option is 1.56" PN 2022108946. However, using the previous gear rack images to identify the notch, order the kit number listed below.

Callout	Kit #	Description
A	<a href="#">2022108946</a>	1.56" Notch
B	<a href="#">2022108947</a>	1.75" Notch
C	<a href="#">2022108948</a>	1.56" Double Notch

**NOTE:** Gear racks in (A) 2022108946 1.56" Notch and (B) 2022108947 1.75" Notch are 38" and can be cut to length. Gear racks in (C) 2022108948 1.56" Double Notch are 32" and can **NOT** be cut down. For the 1.56" Double Notch gear rack lengths other than 32", please contact Lippert Customer Care Center at (432) 547-7378.

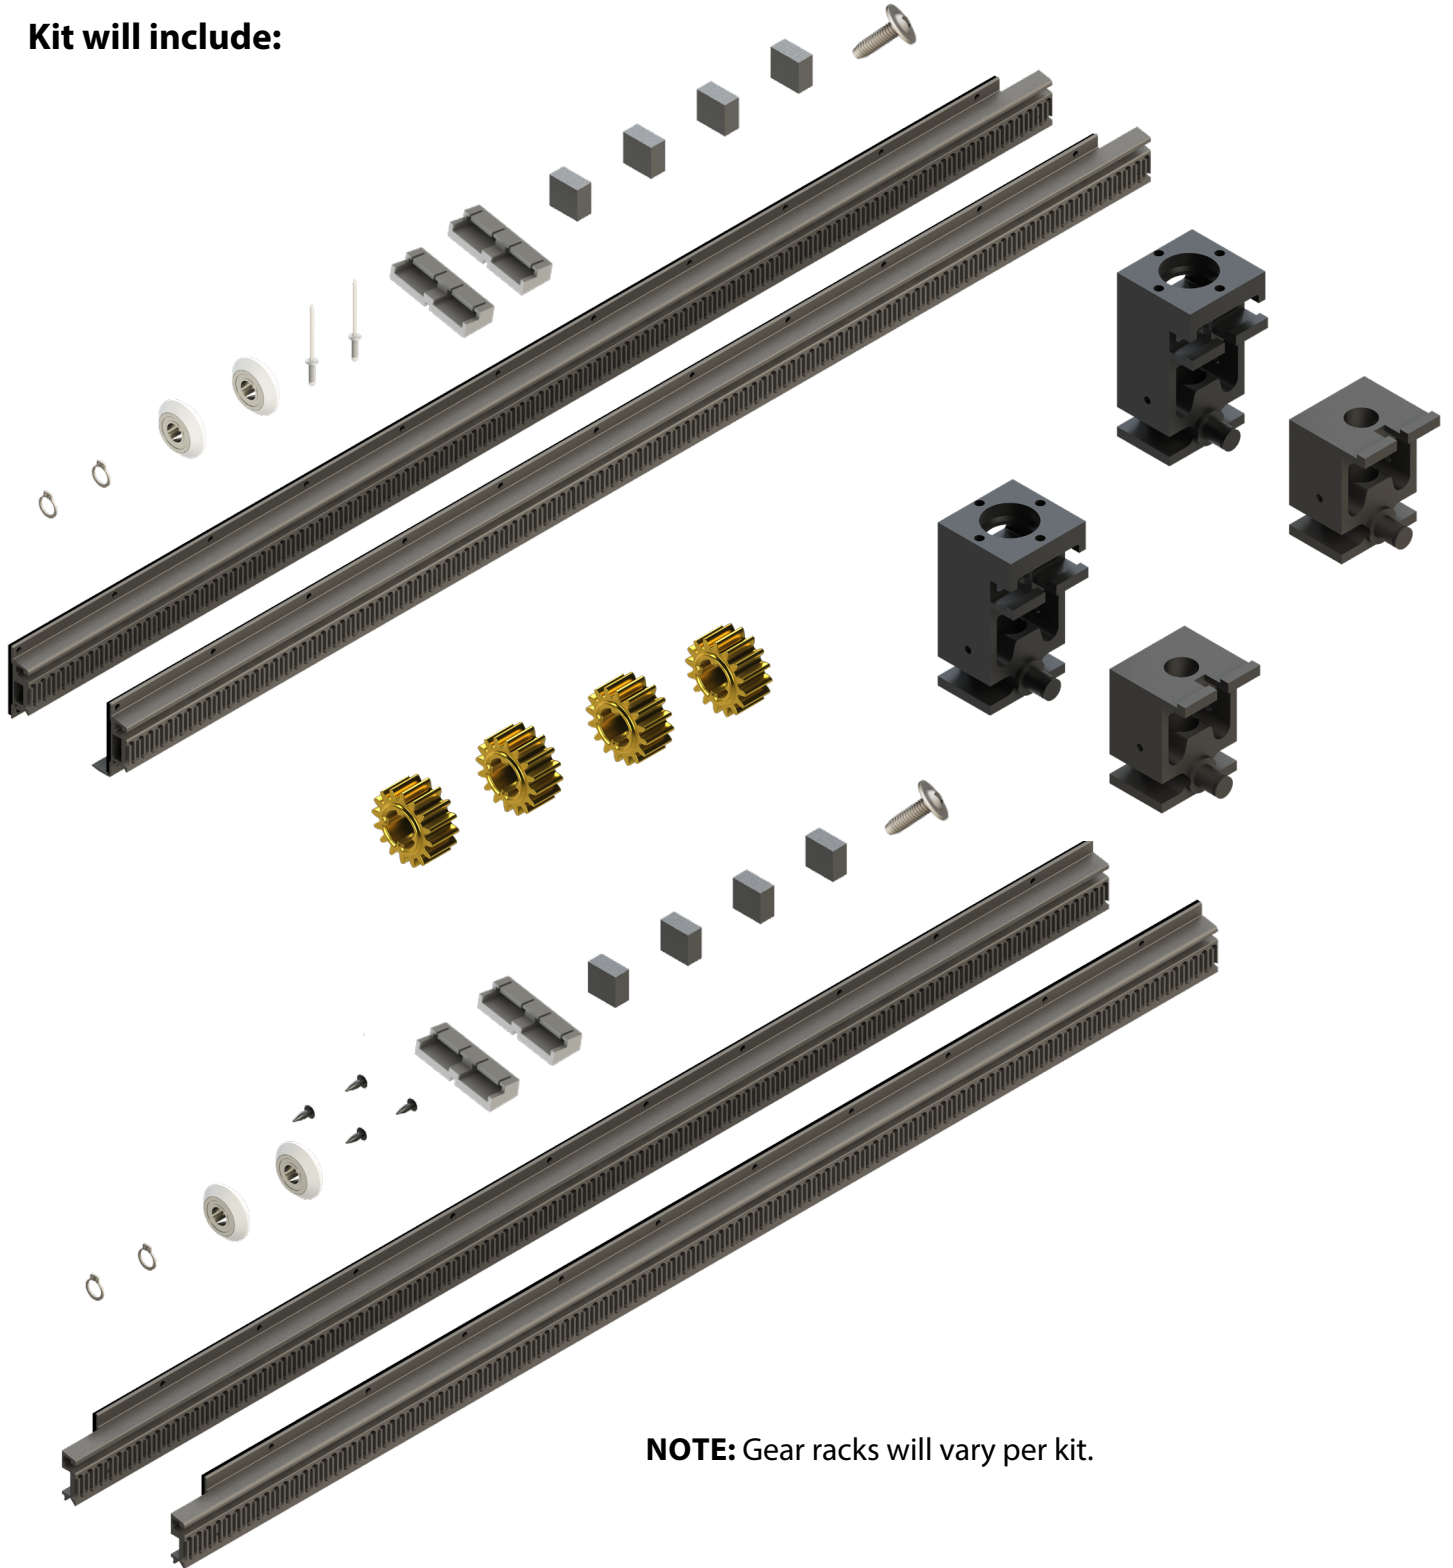
## Kit will include:

**NOTE:** Gear racks will vary per kit.

**NOTE:** The kit includes replacement parts for both the fixed and float sides of the system. It is important to replace BOTH sides and use ALL of the components when repairing units built during the October 2021 through the January 2022 timeframe.
