REPLACEMENT OF THE INVERTED GEAR RACK IN-WALL (SCHWINTEK) SLIDE-OUT SYSTEM

TSB Number:	146-001-2022D		
Product:	Inverted Gear Rack In-Wall Slide-Out System manufactured between October 2021 and January 2022		
Date:	Aug. 26, 2024	Labor Rate:	3.4 Hours Allowed (1.7 hours per side)

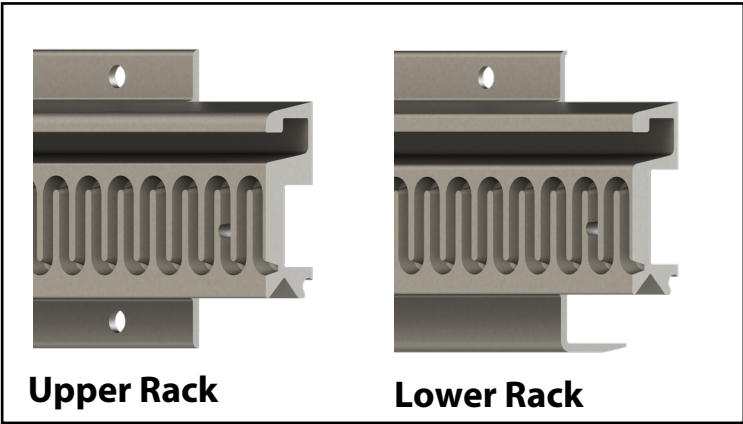
The inspection will be to validate the system as being part of the Inverted Gear Rack In-Wall Slide-Out system. The profile of the gear rack will be as shown below under the subsection "Identifying The Inverted Gear Rack In-Wall Slide-Out System."
