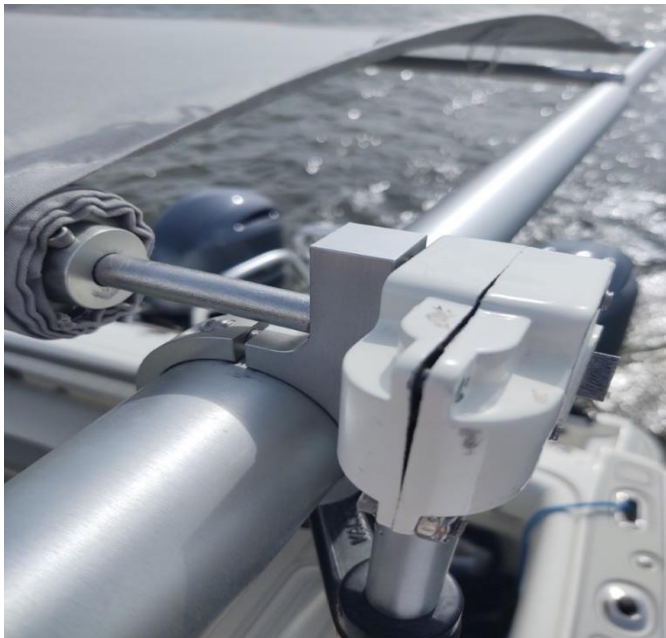
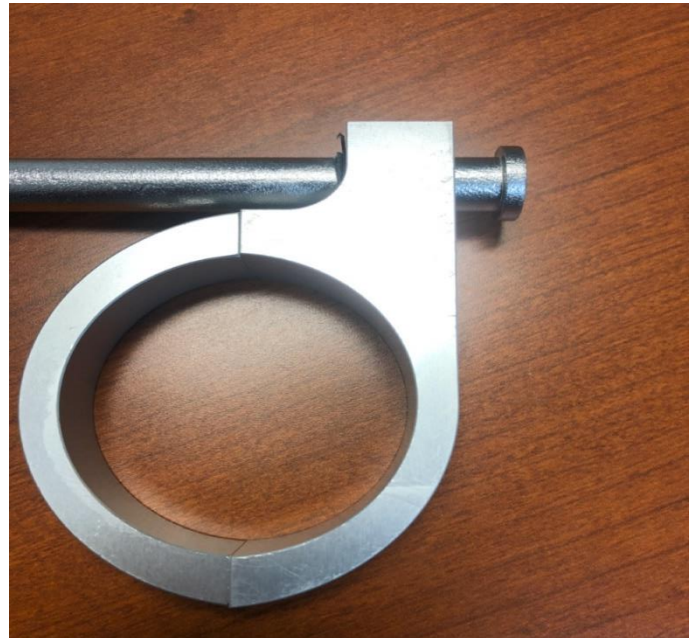
If your port side mount shows the axle not resting firmly on the mount (see pic below) but has a space and the bushing is pushed out, this is generally caused by the unit not being squarely mounted. This can also be caused by the axle not being installed correctly. Make sure the bolts go through the axle threads and is tight.
