SLIDE-OUTS

Purpose

This document outlines the procedure for correcting a crowned inner tube of a through frame slide-out caused by a bound gear pack. In the event that a through frame slide-out gear pack binds, the inner tube of the slide-out may be pushed upward creating a condition that crowns or bends the top of the outer tube creating enough space that will allow the gear pack to periodically skip teeth. The following field fix remedies the occurrence.

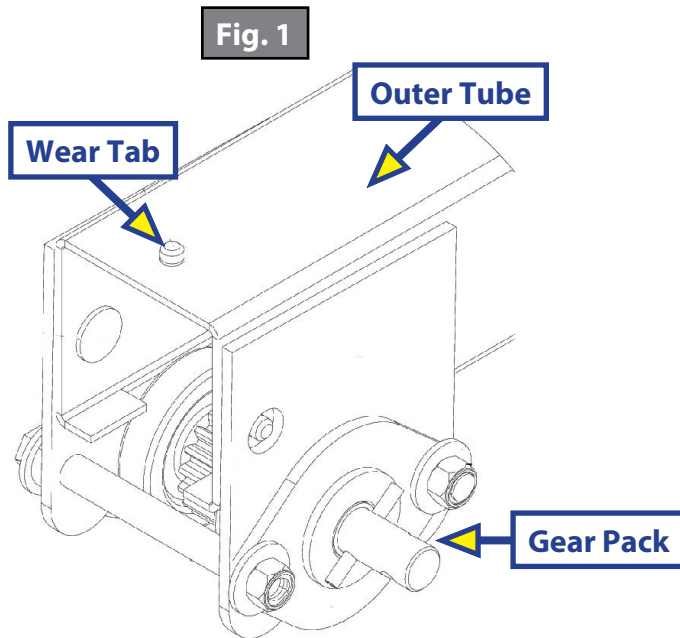
1. Extend slide-out room.
2. Locate the end of the slide-out assembly where the gear pack is fastened (Fig. 1).
3. Inspect top of outer tube for crowning, where top center of tube is higher than top sides (Fig. 2).
4. If outer tube is crowned, tap portion of the wear tab protruding from the top of the outer tube down, being careful not to remove the wear tab (Fig.3).

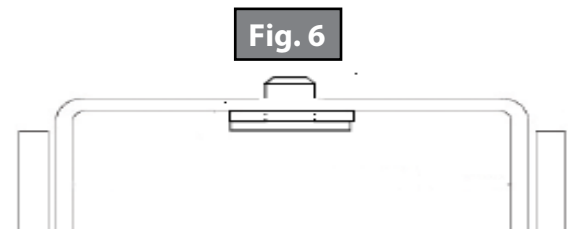
5. Take a 5/16" flat washer (Fig. 4), and remove a notch equal to the diameter of the hole (Fig. 5).
6. Slide the notched washer into the gap created when the wear tab was tapped out (Fig. 6).
7. Slide a pry bar or screwdriver under the cap of the wear tab and push it up to seat it properly into place.
