SureShade – Internal Actuator Drive Inspection

For reference in the event the motor and drive assembly seem to be disengaged from each other due to over-retraction of the actuator. If the actuator bottoms out from over retraction, it is possible with continued retracting of the framework the screw mechanism can be pulled away from the motor engagement. This document describes the steps in disassembling the internal components so a technician can inspect and correct the issue. If the SureShade system is integrated inside a hardtop cavity, the actuator should be removed from the hardtop.

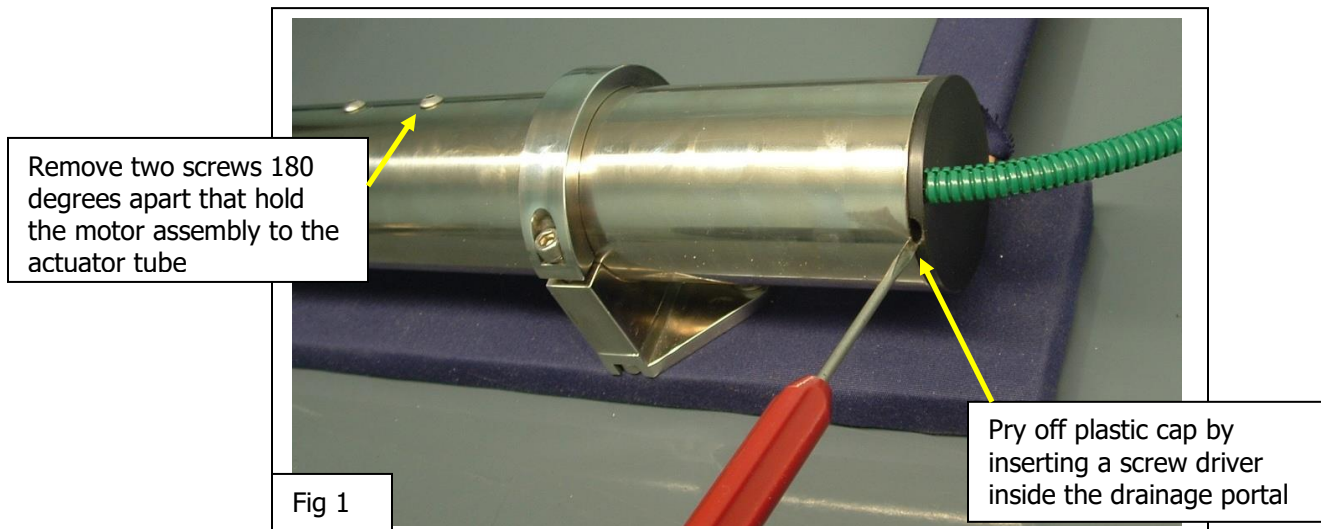
To remove the motor assembly from the actuator's stationary tube, insert a screw driver into the drainage portal and pry off the plastic cap. Then remove the two screws (180 degrees apart) that hold the motor assembly in place (Fig 1).

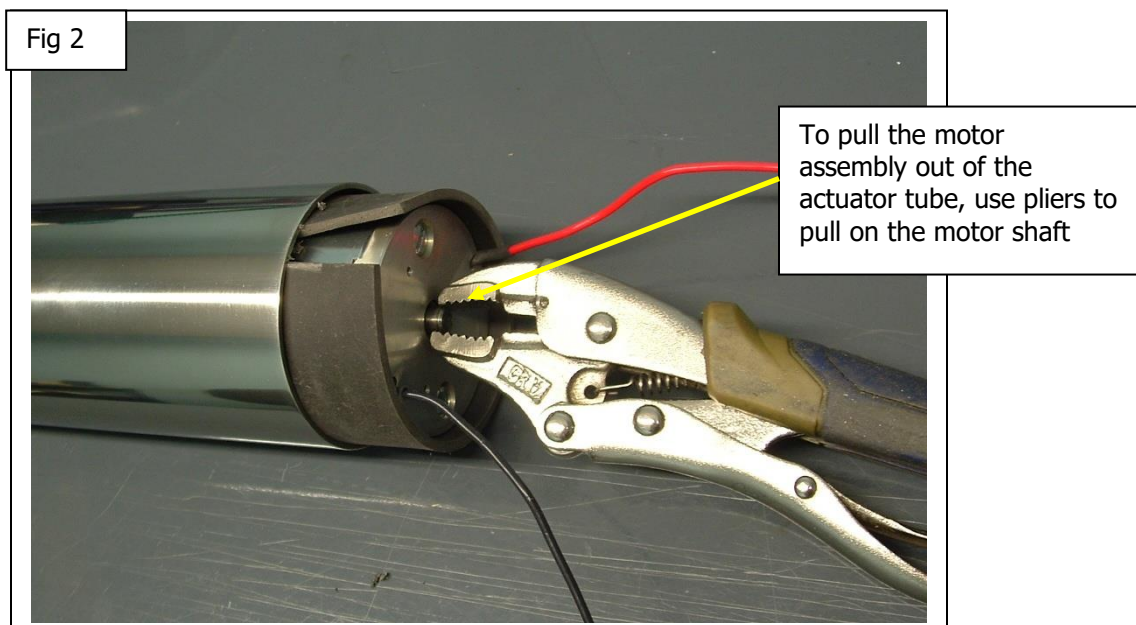
Grab the back end of the motor shaft with pliers to pull the motor assembly out from the actuator tube (Fig 2).

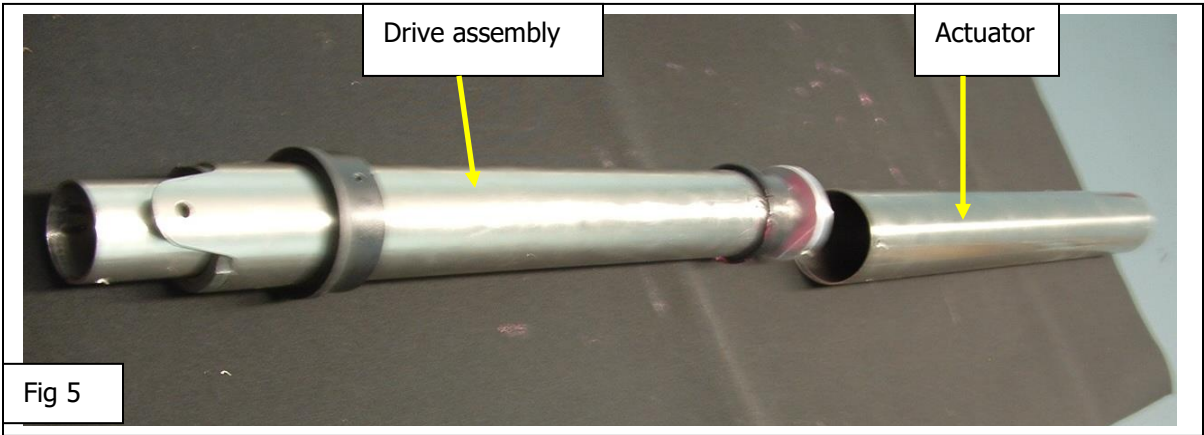
With the screws removed, you can pull the entire drive from the actuator tube (Fig 5).

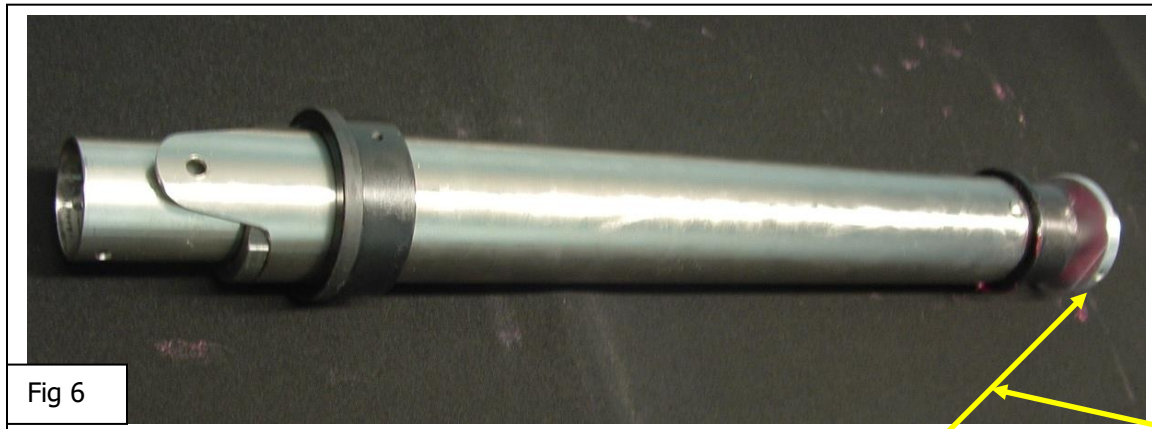
Inspect the end of the drive system to see if the lead screw has been pulled from the locking collar shown in Fig 6 creating a disengagement from the motor.

Inspect the end of the drive assembly

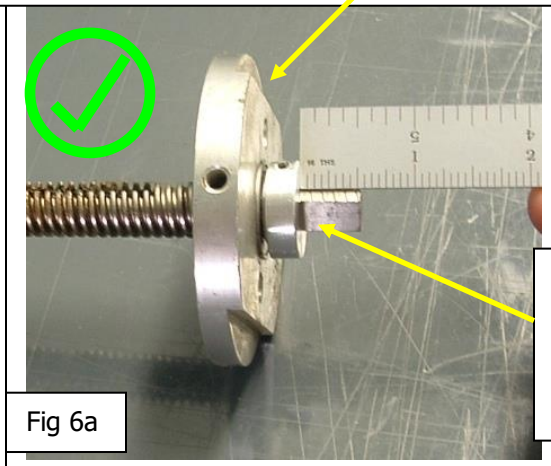
Fig 6a

The lead screw should stick out approximately $\frac{1}{2}$ from the shaft collar

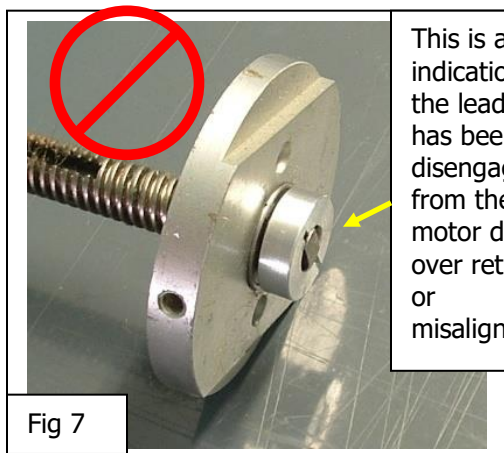
Fig 7

If the lead screw is flush with the collar as shown in Fig 7, the screw has been pulled from engagement to the motor due to over retraction. In this situation you will need to remove the collar from the shaft (Fig 7a) and press the lead screw mount along with the bearing down to its proper position and then secure the collar back to the shaft.

This is an indication that the lead screw has been disengaged from the motor due to over retraction or misalignment.

To correct the issue, remove the collar and press the mount along with the bearing down to the shoulder on the lead screw. Then resecure the collar.

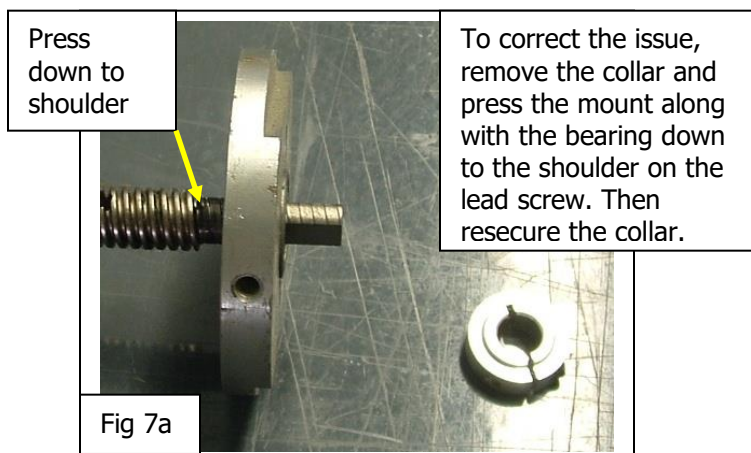
Fig 7a

Press down to shoulder

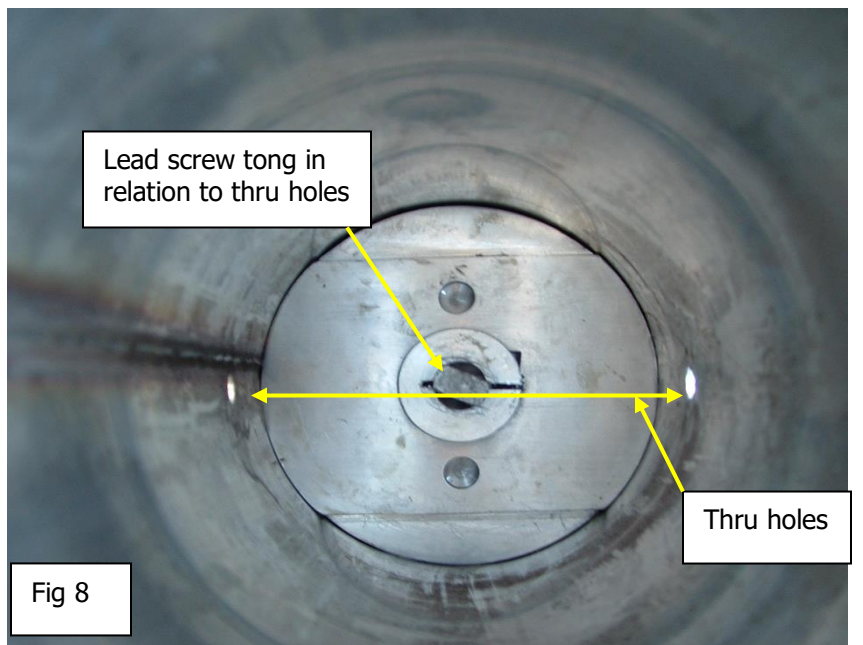
Fig 8 – Look into the actuator tube to determine the position of the lead screw tong in relation to the position of the thru holes for securing the motor to the tube.

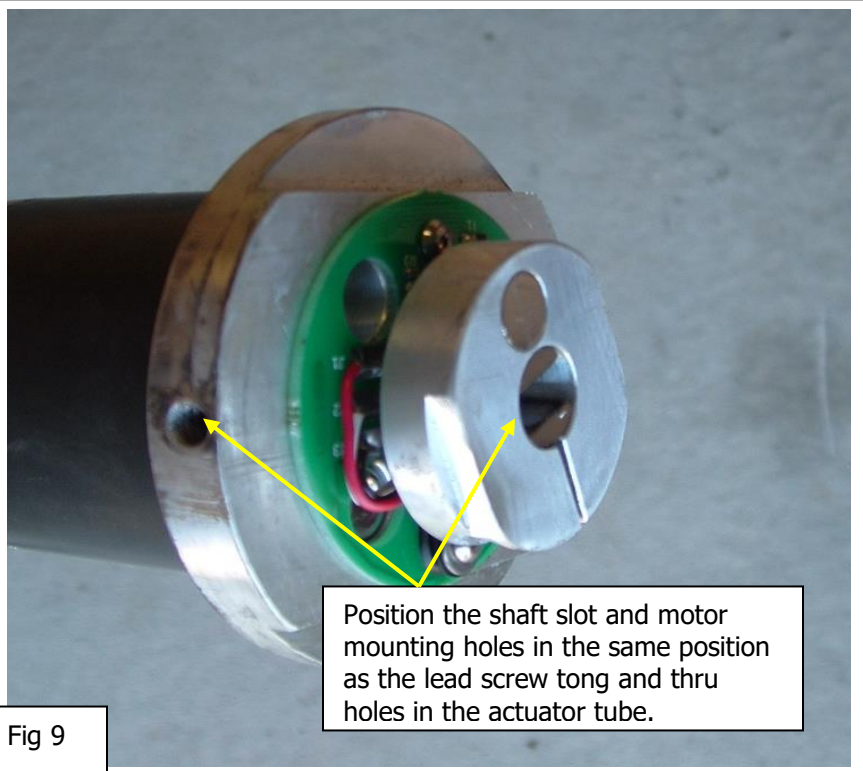
Fig 9 – Rotate the motor shaft slot to line up with the lead screw tong in relation to the position of the thru holes.

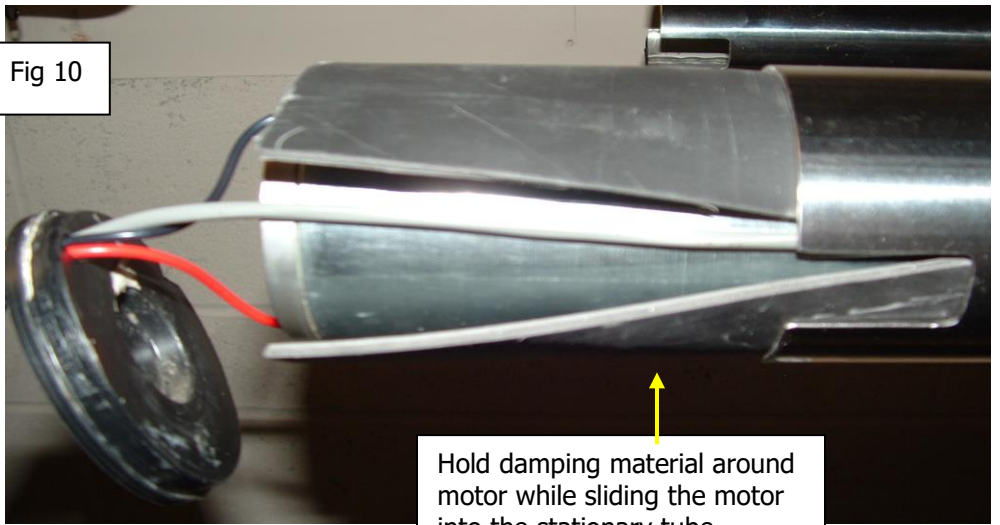
Fig 10 – Wrap damping material around motor. Slide the motor assembly with the damping material around the motor into the actuator tube until motor is engaged with the lead screw and mounting holes line up with thru holes.

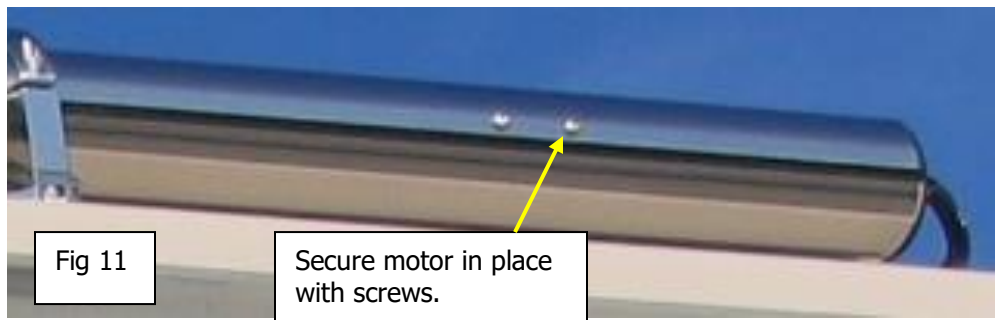
Fig 11 – Secure motor in place with screws.

Secure motor in place with screws.

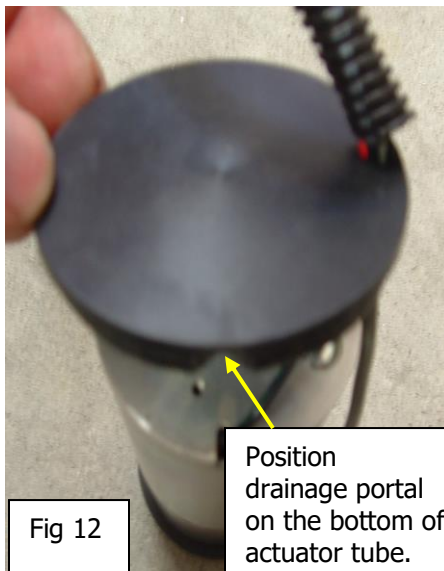
Fig 12 – When positioning the end cap on the end of the tube, place drainage portal at the bottom.

Position drainage portal on the bottom of actuator tube.

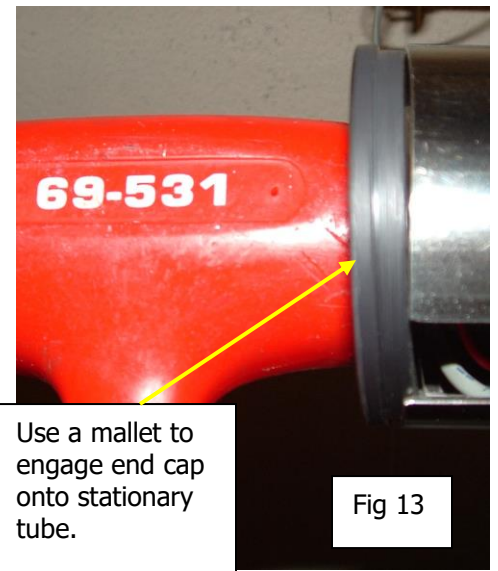
Fig 13 – Use a mallet to hit and secure the end cap into the stationary tube.

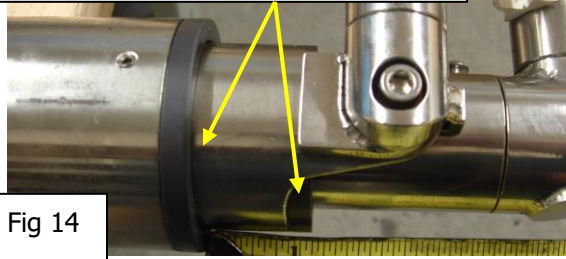
Fig 14

When fully retracted, this dimension should be 1 1/8" from the face of each black plastic sleeve.

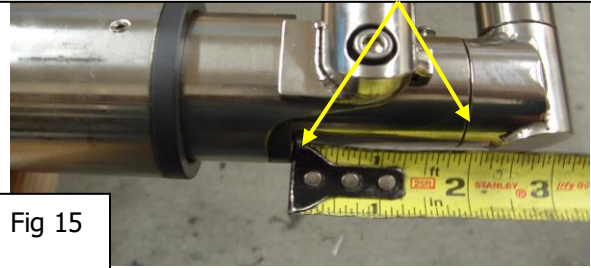
Fig 15

When fully retracted, this dimension should be 1 7/8" from the end of the tube (not including the crossbar insert) to the face of the black plastic sleeve.

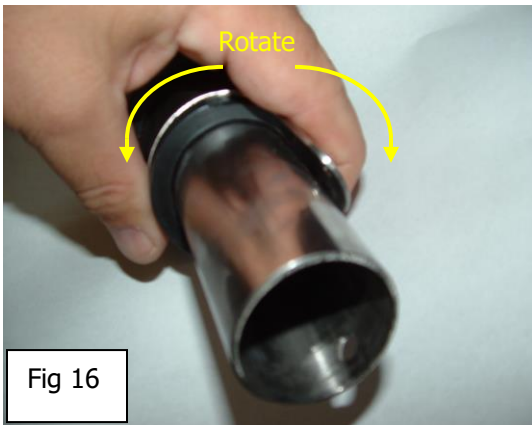
Fig 16

With the crossbars disconnected, adjust the tubes by turning off the power to the unit and rotate the tubes to match each other in extension. Rotating the tubes clockwise will screw the tube into the stationary tube (reducing the length) and counterclockwise rotation will screw the tube out of the stationary tube (increasing the length). Once both actuators are at the same length, reassemble the crossbars and power.
